A small rock avalanche in toppled schist, Lake Wanaka, New Zealand

G.S. Halliday

Tonkin & Taylor Ltd., Wanaka, New Zealand

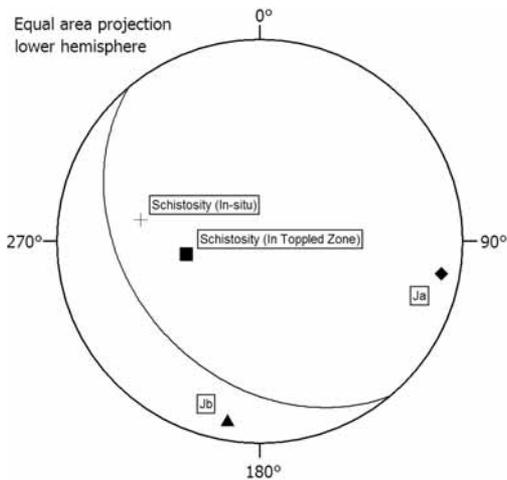
Figure 4. Lower hemisphere, polar, equal area stereoplots of mean attitudes of rock defects. The great circle indicates average dip of slope surface in the rock avalanche source area.

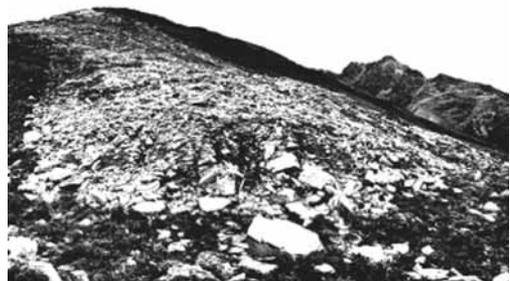
The slopes above the highway were examined by helicopter and on foot. A lobe of rock avalanche debris was visible on a glacial bench high above the road, and the travel path could be traced back to the source area on the hillside above (Figure 5). The bulk of the debris had stopped on the bench, but some boulders continued rolling and bouncing over the bluffs towards the lake, with a small proportion hitting the highway. Their routes could be traced by tracks left in the scrubby vegetation (Figure 6).

Figure 5. View of the rock avalanche from the toe.

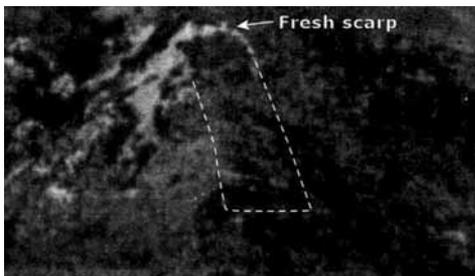
An aerial photograph taken several years before the rock avalanche (Figure 7) shows a pre-existing fresh scarp around the head of the source area.

Figure 7. Source area prior to failure showing fresh scarp around head region, remaining boundary indicated.

Large-scale toppling is widespread in the schist rock adjacent to the failure area and above other sections of the Haast Pass Highway, and rockfalls and rock avalanches present a hazard to the road. It may be possible to gain warning of future failures by aerial examination of the slopes for precursory scarps and tension cracks.
