Embankment Failures – Local Experiences

E. G. Maynard ¹, BE (Hons) Nat Res, MEM, GIPENZ

ABSTRACT

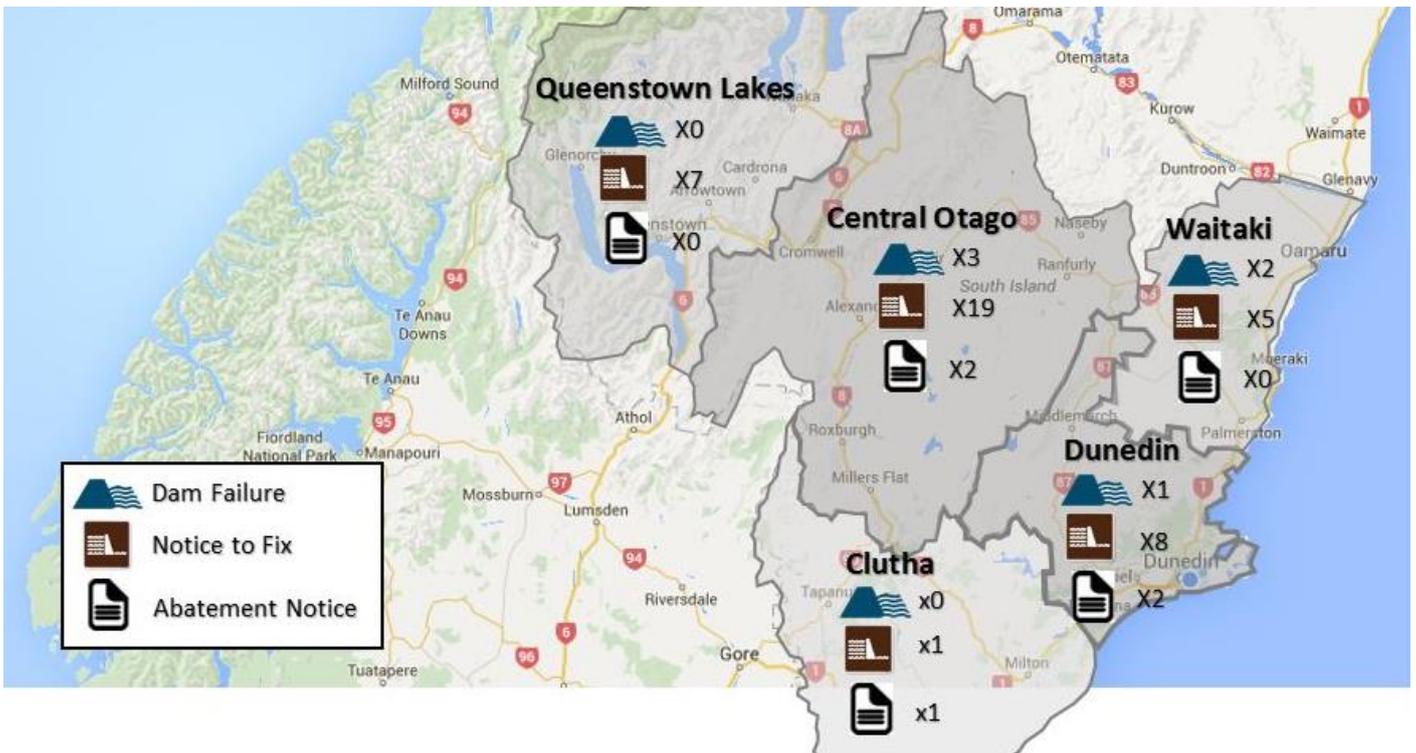
Figure 1. Failure rates and dam enforcement for dams in Otago since 2011.

The Otago Regional Council (ORC) is responsible for issuing building consents for large dams and compliance matters for all dams in Otago. Since 2011, the ORC has documented six dam failures, issued 40 notices to fix for non-compliance with the building code, and five abatement notices for dams in breach of the RMA (refer Figure 1). These equate to approximately one incident per month. The most precarious dams in the database are summarised in Table 1.

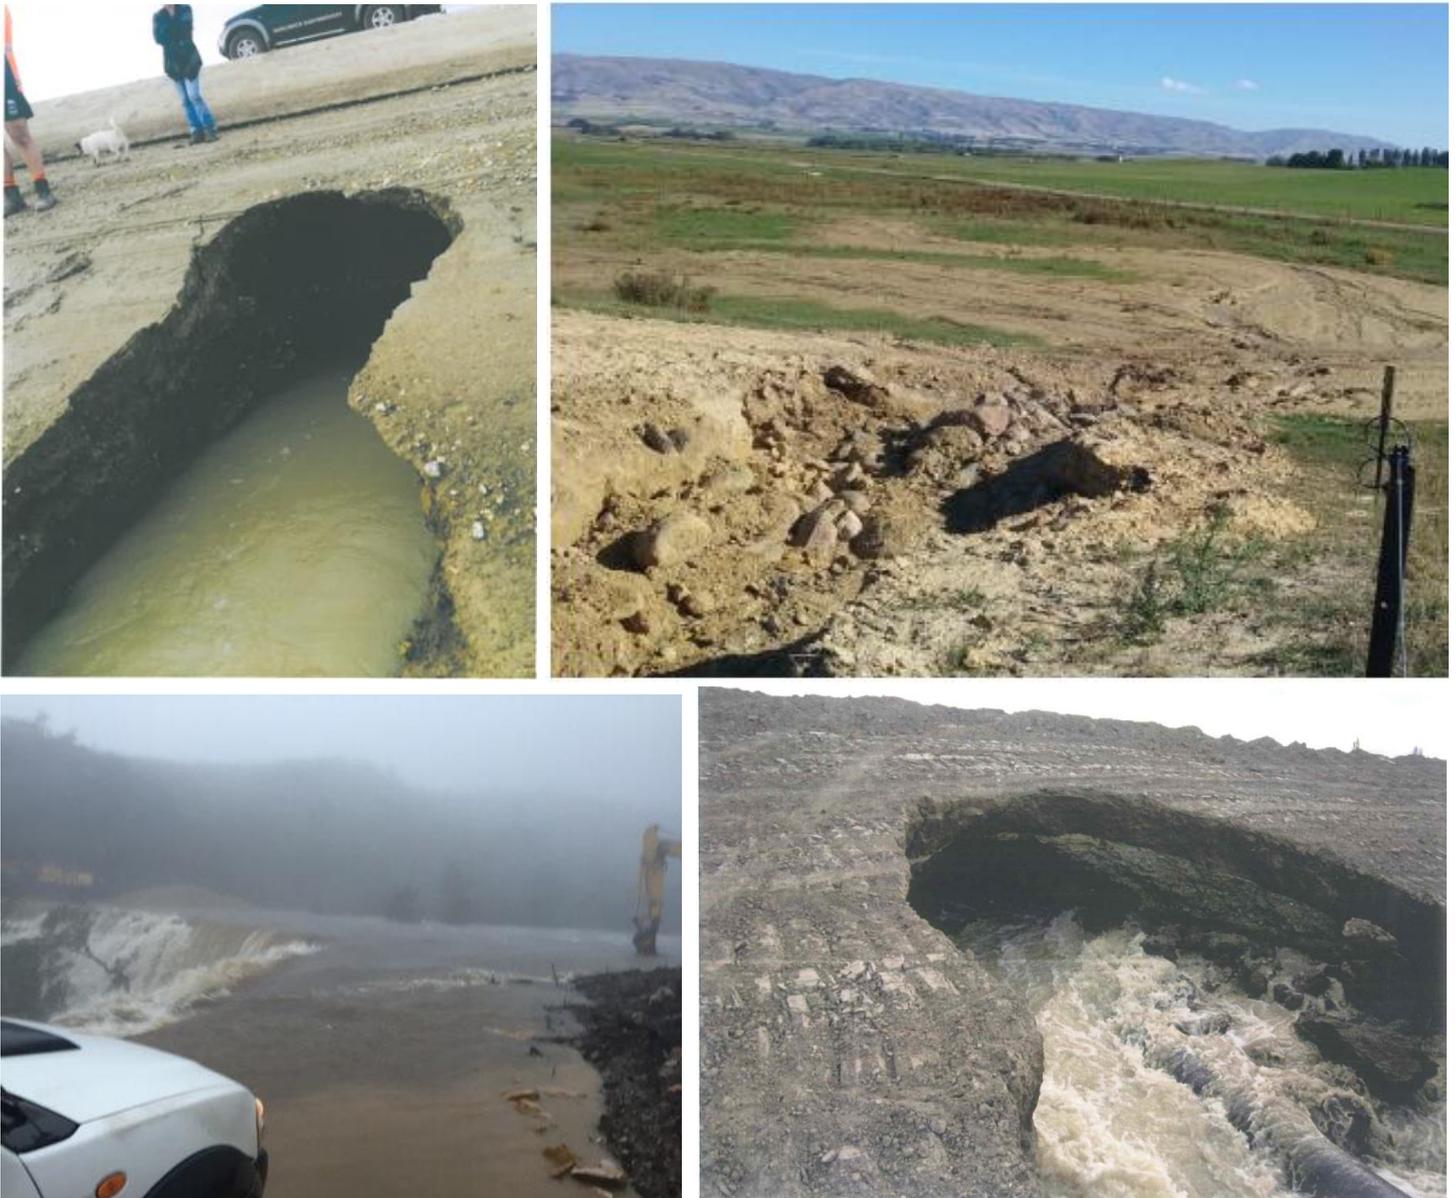
Figures 2 to 5. Clockwise from left:

Figure 2 Case Study A – Foundation piping failure at downstream dam toe immediately post failure;

Figure 3 Case Study B – Erosion of spillway throat and deposited sediment down plain post failure;

Figure 4 Case Study C – Piping failure around conduit viewed from the downstream toe during failure;

Figure 5 Case Study D – Crest overtopping during flood.

Failure mechanism: Seepage at the foundation contact leading to headward void migration and subsequent piping failure soon after first-filling. This is one of the most common form of distress on initial filling of a reservoir.

- Planar compaction surfaces with rare clumps of turf that would tend to facilitate piping
- Permeable gravel lenses providing an environment that readily transmits high pore water pressures at the foundation interface
- Sinkholes observed in the reservoir floor suggesting permeable gravel lenses do not meet filter compatibility with overlying silt

Failure mechanism: Erosion of the spillway lining and part of the embankment during sustained rainfall of moderate intensity (20-30mm of rain over 24hrs).

- Incompatible liner materials, being coarse graded riprap overlying erosive/dispersive silt
- Coarse riprap tending to induce turbulence causing entrainment of finer soils
- Hydraulically steep spillway (embankment slope ~15-20°)
- Flows of damaging magnitude entering the reservoir from an external source, possibly from sidling runoff beyond the natural catchment conveyed into the reservoir via a water race

Failure mechanism: Piping of soils along the outside of the conduit caused by tractive hydraulic forces from the reservoir leading to erosion of the downstream toe and subsequent headward breach migration, i.e. FEMA's Failure Mode 3 (Federal Emergency Management Agency FEMA, 2005). Failure occurred shortly after first filling.

- Lack of provisions for the safe passage of seepage along the pipe without entraining fines
- Accounts from the contractor are of the inlet screen displacing laterally under high wind causing uplift, permitting water ingress along the conduit
- Trenching method and inability of compaction plant to suitably compact fill around the conduit
- Fill around the pipe being potentially dispersive and/or erosive
- Silty gravel layers near the foundation toe

Failure mechanism: A significant rain event overwhelmed three bypass culverts, causing water to build up behind the embankment resulting in subsequent crest overtopping and scour to the downstream slope.

- Hydraulically steep slope batters (embankment slope ~45°)
- Insufficient pipe strength resulting in at least one bypass culvert being crushed under the embankment weight
- Debris from upstream clogging the bypass culverts
- Significant rainfall, probably in excess of the design event expected for this structure

Remediation: Undertake engineering inspection of the stripped foundation, investigate the persistence of permeable strata at/near foundation level, reduce compaction thickness, utilize a sheepsfoot roller. A new keyway and additional shoulder material was formed on the upstream dam slope.

Remediation: A new spillway with riprap liner and geotextile underlay was formed into natural soil.

Remediation: The pipe was re-laid with the inlet screen secured. A filter diaphragm and filter drain was installed for the downstream pipe section. New clayey silt was imported and compacted around the pipe by a small mechanical tamper.

Remediation: The culverts were upgraded with stronger, larger pipes with debris screens. A new high-level spillway was provided at the true left abutment. Embankment slopes were eased.
