Jackson Creek landslide stabilisation, New Zealand

ABSTRACT: This paper describes the investigation, design and construction of the stabilisation measures adopted for the active downstream segment of the Jackson Creek landslide situated within the Clyde dam reservoir, New Zealand. The Jackson Creek landslide is one of a number of landslides being stabilised by the Electricity Corporation as part of the Clyde Power Project, New Zealand. It is a 5 million cubic metre, scarp slope, schist landslide that posed wave and blockage hazards to the proposed reservoir. The principal stabilisation measures were a 0.7 million cubic metre buttress and drainage of the groundwater systems from drives.

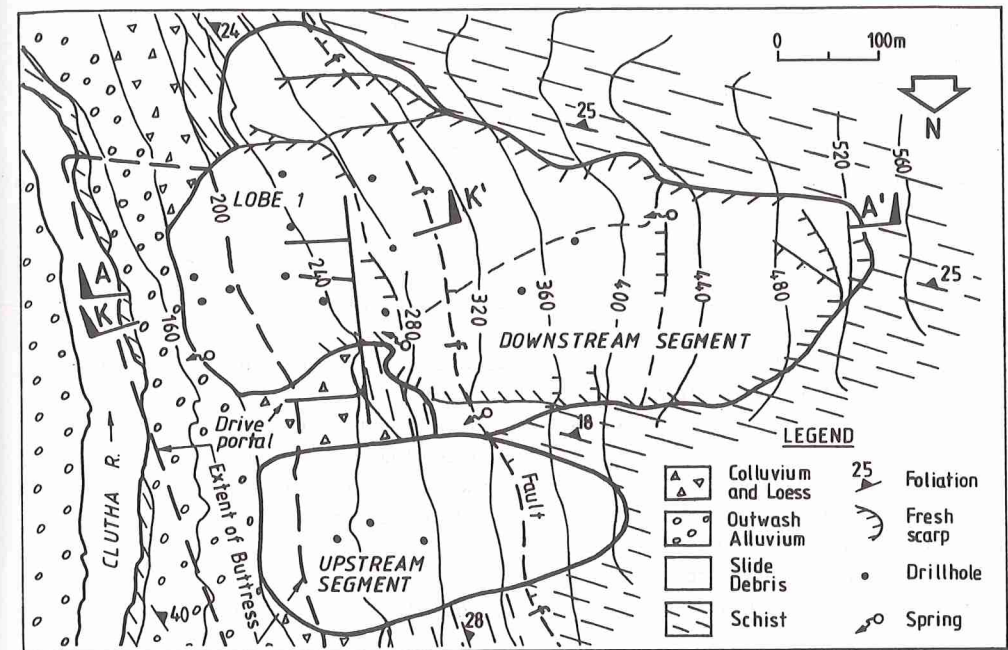
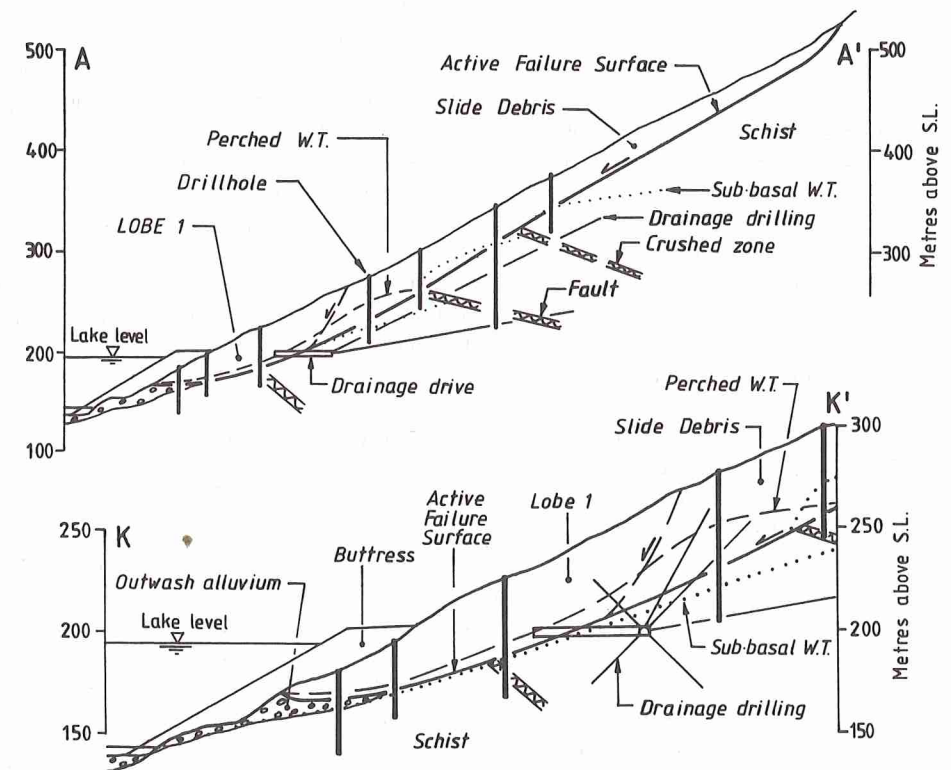
Figure 2. Geological map and cross sections

The downstream segment is an active translational feature consisting of a layer of schist debris sliding on bedrock (Fig. 2). The slide is up to 46 m thick, and the ground surface has an average slope of 30°. It occupies the floor of a large topographical depression and appears to be the remnant of a former larger feature.

The basement rock is textural zone IV schist consisting of alternating laminae of quartz/feldspar and mica. Foliation dips at 20 - 40° into the slope beneath the lower part of the slide. The attitude changes abruptly to a 20 - 40° downstream dip above a fault that trends beneath the slide at midslope (Fig. 2).

Another series of faults and crushed zones dip at 20°-40° into the slope beneath the slide base (Fig. 2). These strongly influence the fundamental watertable as described below.

Springs existing at the toe, and piezometer measurements indicate that a perched watertable lies in the trough of the slide, above the low permeability basal crushed zone. The watertable rises steeply across the rear of the lobe 1, due to the ponding of water behind the lobe failure surface (Fig. 2).

A series of drives was excavated below the slide in sub-basal rock, with two stubs being excavated back through the slide basal surface (Fig. 2). The drives provided access for the drilling of drainholes and also provided valuable investigation data on sub-surface geology.

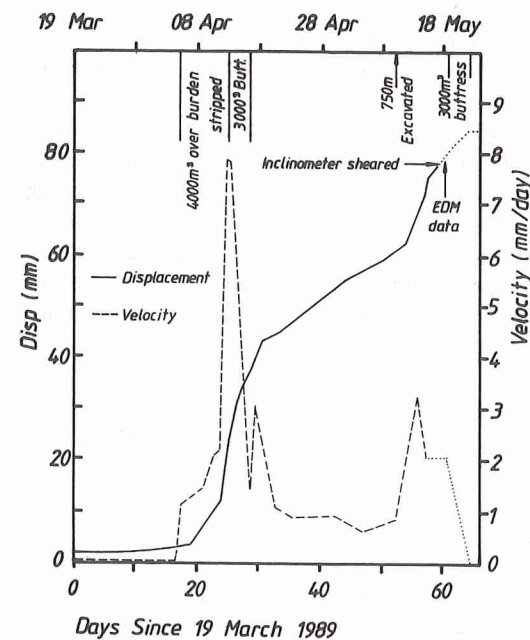
Figure 3. Displacement and velocity of lobe 1

stripping of loess and topsoil from the lower part of lobe 1 resulted in the removal of 4,000 m³ of material from the slide toe. This was calculated to have decreased lobe 1 stability by 2% (Table 2).

Slide response was immediate. Within a few days movement rates increased to nearly 8 mm/day on lobe 1 (a 160 x increase in rate).

The slide continued to move at this rate for 3 weeks, until excavations to widen a haul road resulted in removal of a further 750 m³, representing a 1% stability decrease. Movement rates increased sharply to 2-3 mm/day necessitating the addition of 3,000 m³ to the temporary buttress (RL 175 m). At this stage the inclinometers on lobe 1 sheared, movement rates after this time are based on monitoring of the surface pillars by EDM, which had a lower level of accuracy. These surveys indicated a major decrease in velocity following temporary buttress placement (Fig. 3).

When the main buttress construction reached the toe of the active portion of lobe 1 and began to act on it, movement essentially ceased. Total movement measured during this phase was 83 mm on lobe 1.

The engineering response was to place a 3,000 m³ temporary buttress (RL 173 m) after quickly

stripping failure zone material from the active surface. Replacement of weak shear surface material with higher shear strength alluvial gravels permitted a higher stabilising force to be mobilised. The small buttress is estimated to have restored slide stability to near the original state (Table 2). Movement rates on lobe 1 slowed quickly to 1 mm/day.
