Evidence for coseismic rock avalanches and debris flows in fractured mylonites of the Alpine Fault, Paringa, New Zealand

G.S. Halliday

Tonkin & Taylor Ltd, Wanaka, New Zealand

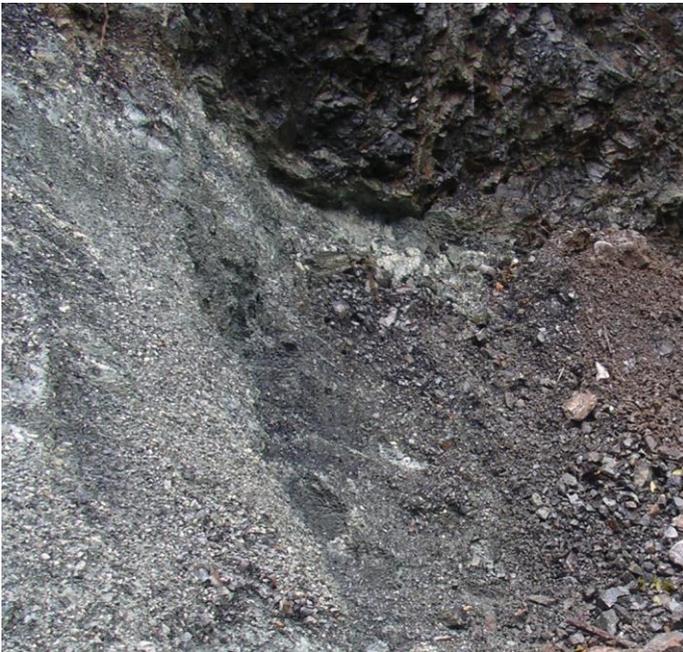
Figure 4. Cataclasite composed of cm diameter fragments of quartz and mylonite in a silty matrix, overlain by shattered mylonite (Photo V. Toy)

The Alpine Fault typically exhibits a low shear strength gouge up to about 0.5m thick along the fault plane. Above the gouge is the weak cataclasite zone up to about 30m thick, composed of angular fragments of quartz and mylonite in a silty matrix (Figure 4). A similar sequence would be expected at Ward Hill.

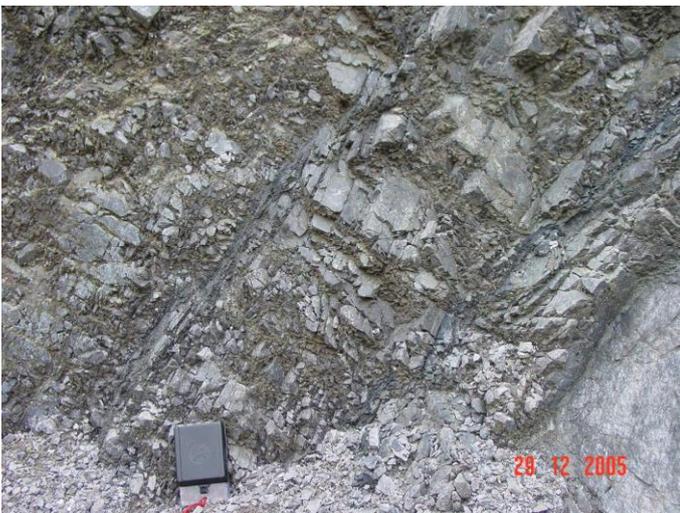
Figure 5. Sheared and shattered mylonite in the AFZ. (Photo V. Toy)

The overlying schist derived mylonites are commonly closely sheared, shattered and altered (Figure 5), and prone to slope instability. Defects comprise foliation shears/ fractures, joint sets orthogonal to
